# Service Information

**SI-No.:** 1000005

Subject: DTCO 4.0f – Upgrade Process

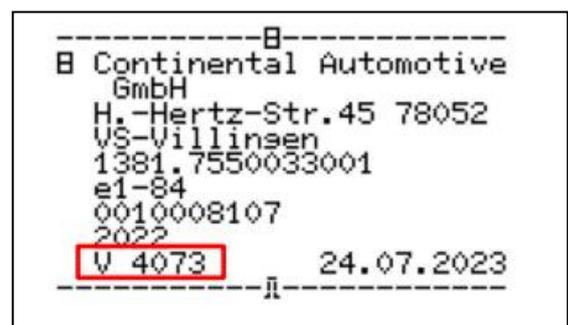
In order to determine the corresponding DTCO version, a technical data printout of the DTCO can be made. The versioning can be checked at the following point:

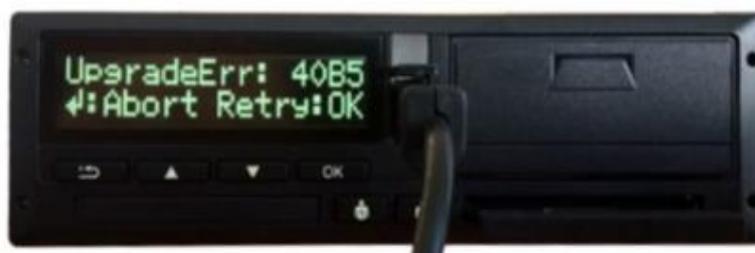
3. Deliberately wait until the DTCO shows you the upgrade error 40B5 (timeout)

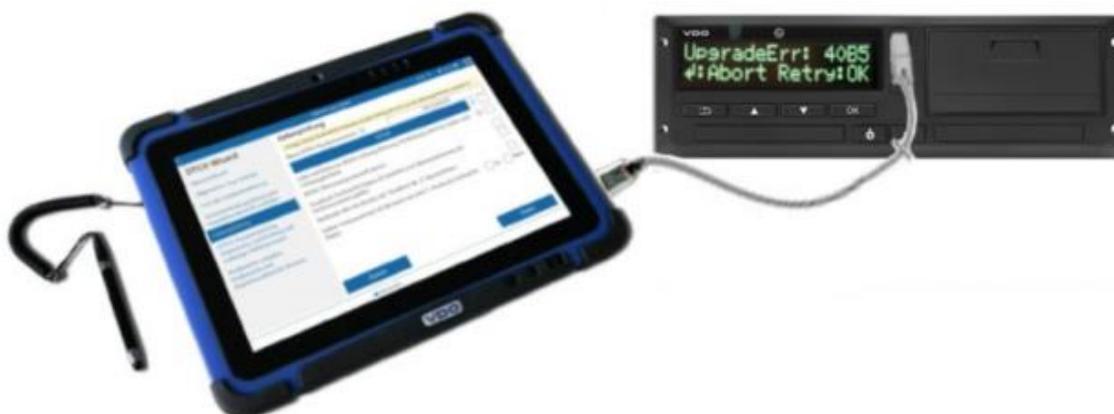
4. Switch to the WorkshopTab and select the Software Upgrade item under TCO Info. Connect the the WorkshopTab with the DTCO via the DTCO update cable.

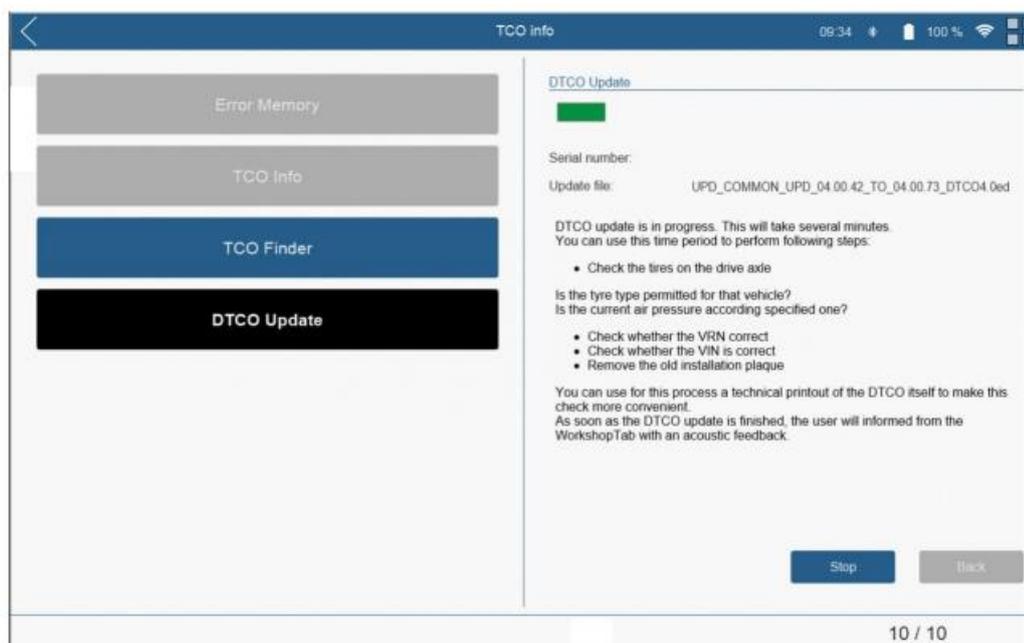
5. Select the appropriate upgrade file ('SN\_10000062-11374059\_4.0(4042)\_TO\_4.0ed(4.0ed.UPF') and the certificate and click on start. You will be asked to enter the old password (contained in the email sent to you) and to enter and confirm a new personal password for the certificate.  
**Note:** For the upgrade of a DTCO 4.0, the same certificate is used as for the DTCO 3.0. Pay attention to the **designation R3** when selecting the certificate.
6. The WorkshopTab then tries to establish a connection with the Tachograph.

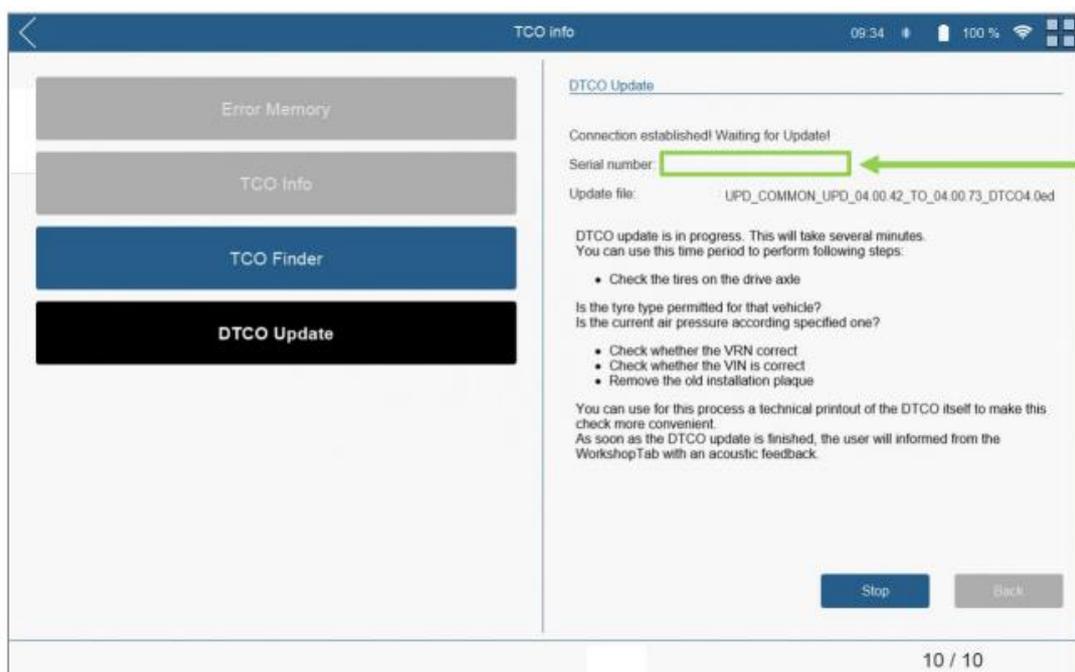
7. The message **Connection established! Wait for upgrade!** appears on the screen of the WorkshopTab. Now press the "OK" button on the DTCO to transmit the serial number.

After the “OK” button was pressed, the serial number of the DTCO will appear in the field

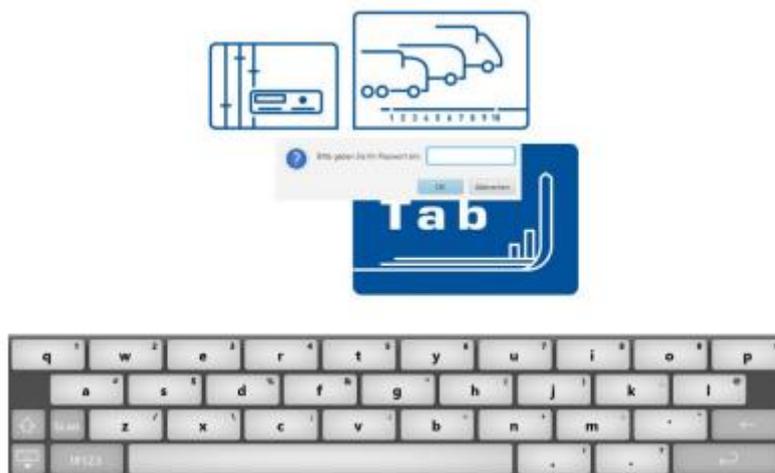
8. Please then enter the personal password defined at the beginning on the WorkshopTab and then confirm this with **OK** or **Enter**.

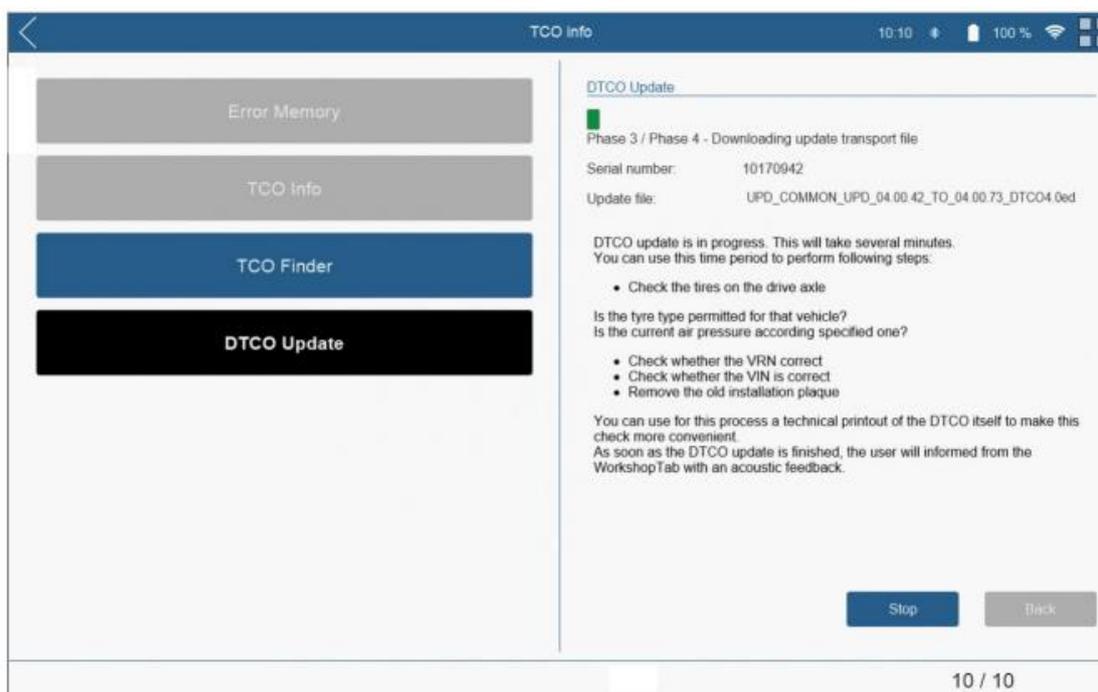
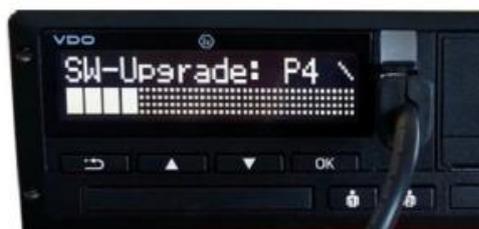
9. Then the software upgrade begins. After authentication, the actual download to the DTCO begins. The progress can be seen on both the DTCO and the WorkshopTab.

The upgrade is completed after a few minutes (from the time the password is entered). At the end of the upgrade, the message “upgrade done” appears on the DTCO.

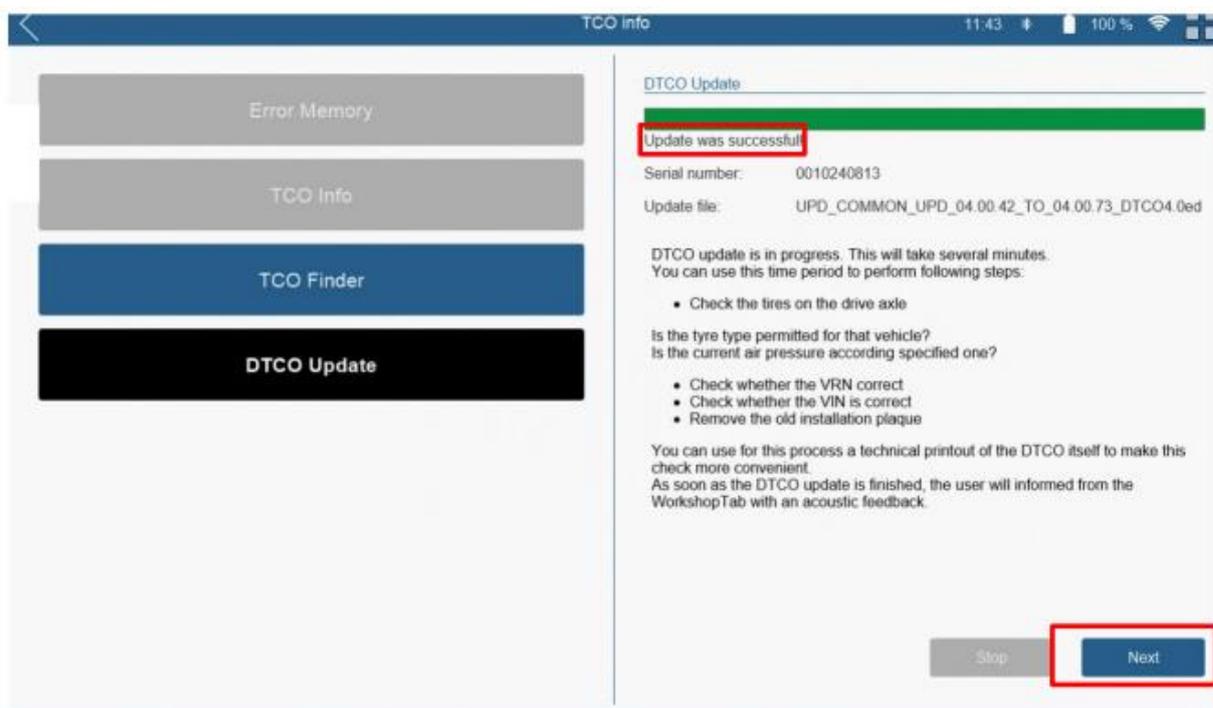
- After the upgrade has been completed, the corresponding message appears in the WorkshopTab and the wizard guides you to the next step.

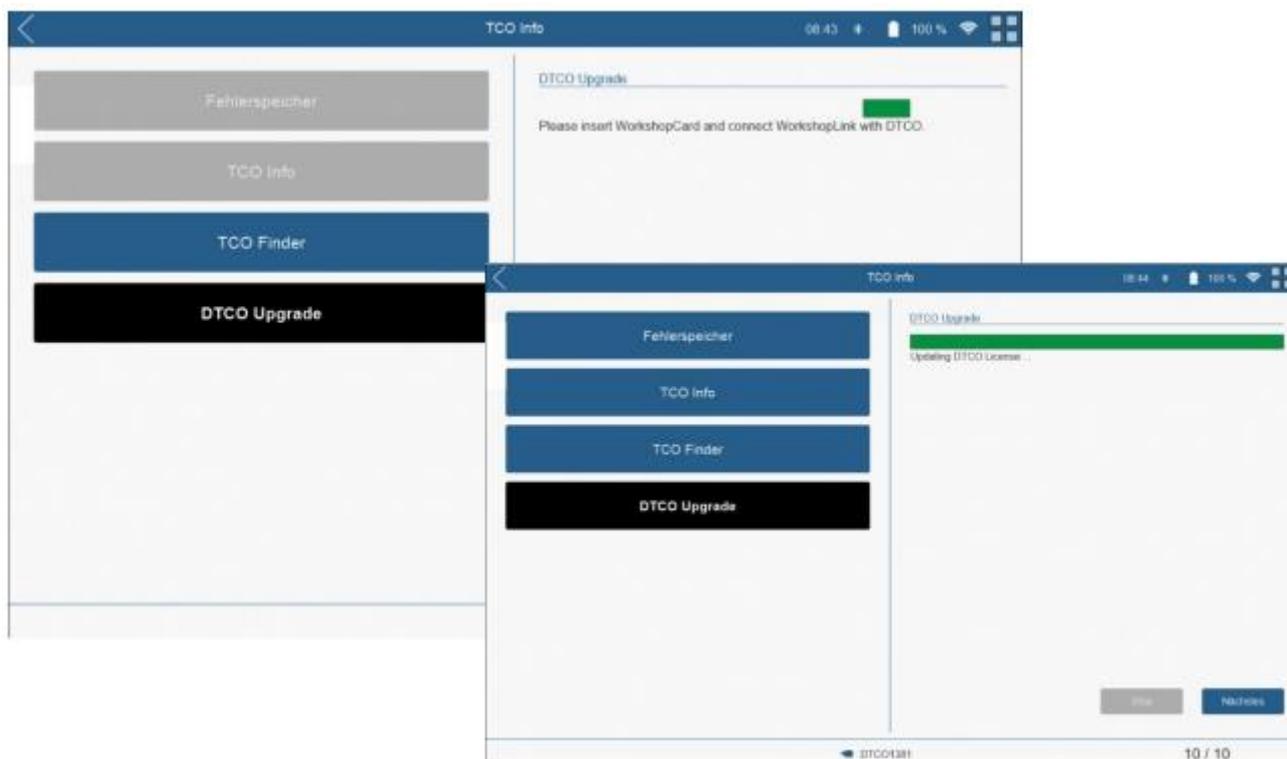
11. You will then be asked to insert the workshop link and the workshop card into the DTCO. Then the license code is written on the DTCO.

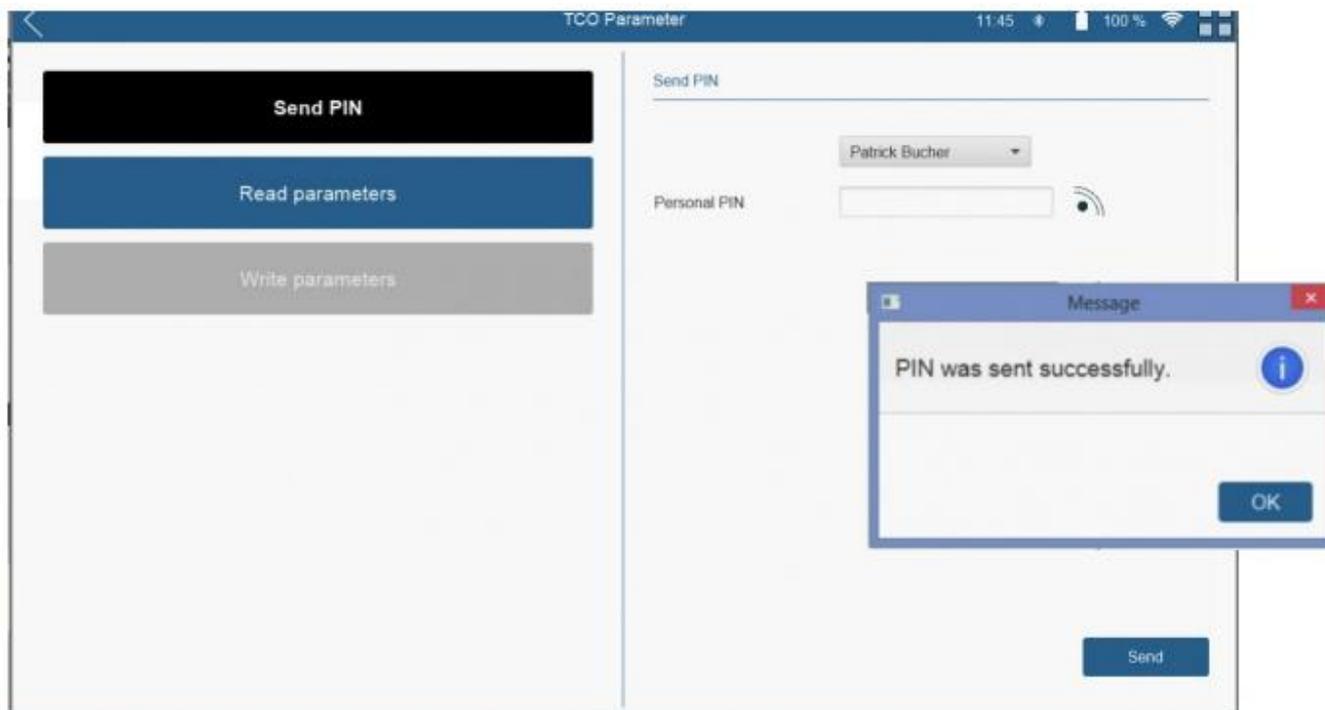
12. Now enter your personal password for the respective inserted workshop card and confirm with "Send".

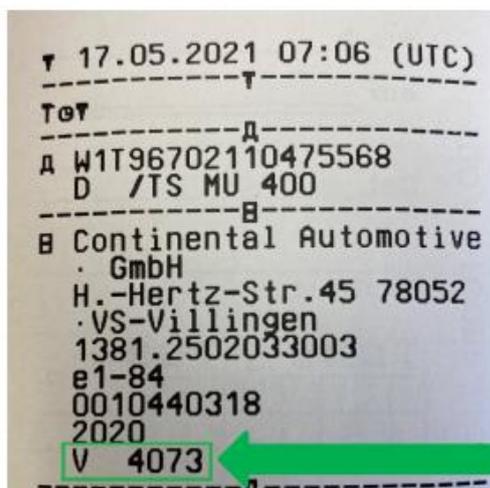
The software upgrade to DTCO Version 4.0e has now been successfully completed. Check the correctness with a technical data printout. Software version 4073 should now be listed here.
